**SAFETY COMPLIANCE TESTING FOR FMVSS 201U**  
**Occupant Protection In Interior Impact**  
**Upper Interior Head Impact Protection**

**DAIMLERCHRYSLER CORPORATION**  
**2003 Dodge Durango SXT 4-Door SUV**  
**NHTSA No. C30305**

**FINAL REPORT**

1. Report No. 201U-MGA-03-004	2. Government Accession No.	3. Recipient's Catalog No.	
4. Title and Subtitle Final Report of FMVSS 201U Compliance Testing of a 2003 Dodge Durango SXT 4-Door SUV, NHTSA No. C30305		5. Report Date January 23, 2003

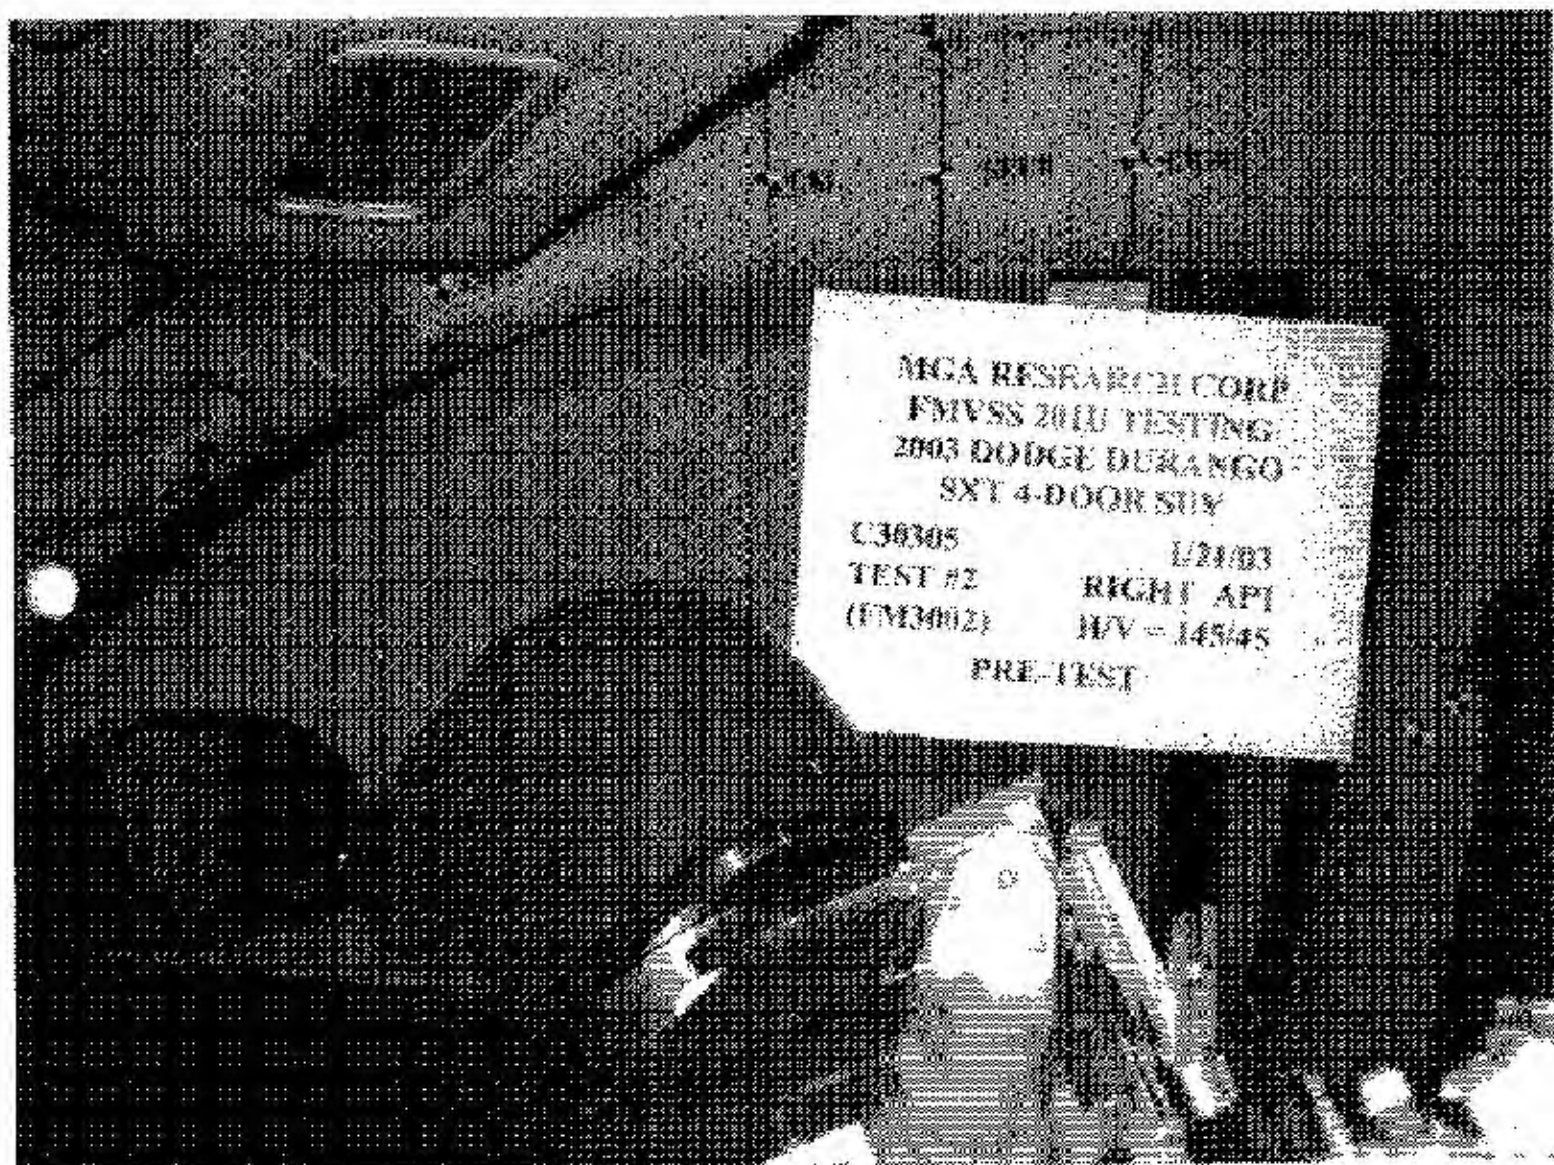
TEST #2 RIGHT API

MGA RESEARCH CORP  
FMVSS 201C TESTING  
2003 DODGE DURANGO  
SXT 4-DOOR SUV

C30305 1/21/03

(FMV3002) H/V = 145/45

POST-TEST

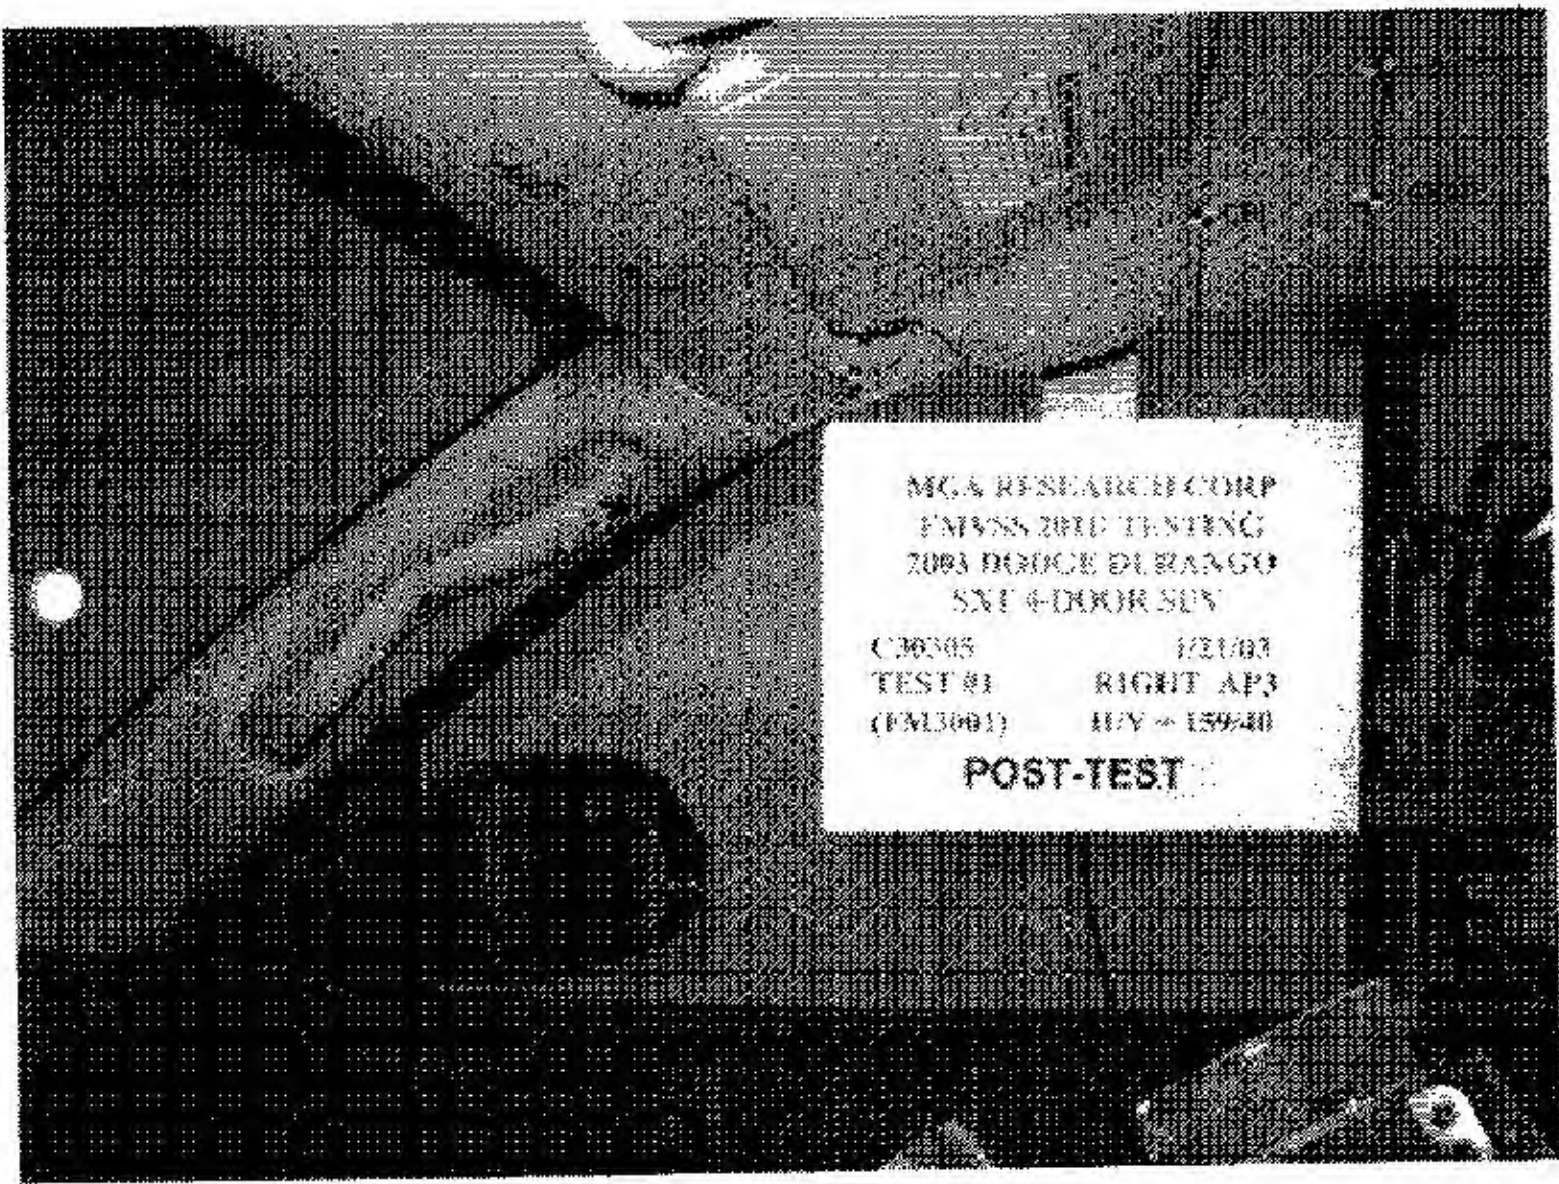
C30305 1/21/03  
TEST #1 RIGHT AP3  
(FMV3001) H/V ~ 139/40

MCA RESEARCH CORP  
FMVSS 201C TESTING  
2003 DODGE D150  
SXT 4-DOOR SUV

ASSET DAMAGE WAS BEST DURING TESTING

AP3 Right: The assist handle was bent during testing.

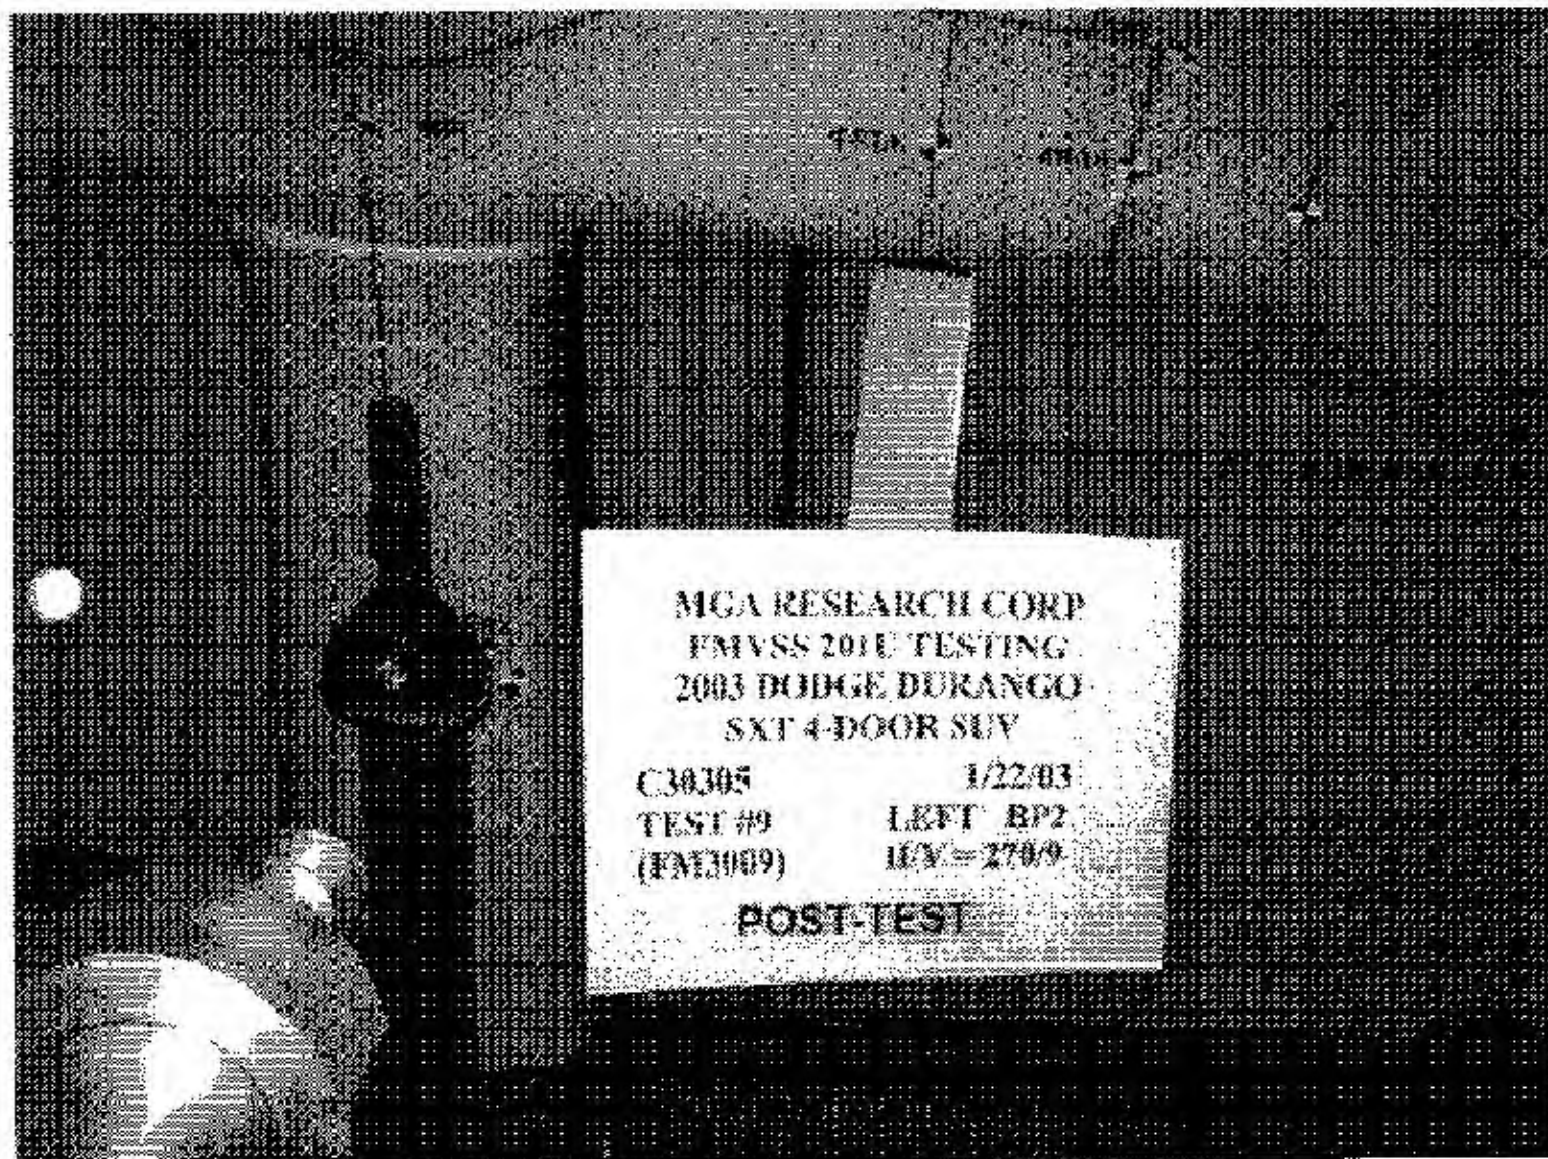
C30305	1/22/03
TEST #9	LEFT BP2
(FMT3009)	ICV = 270/9

MGA RESEARCH CORP  
FMVSS 201E TESTING  
2003 DODGE DURANGO  
SXT 4-DOOR SUV

NO VISIBLE DAMAGE
